Existing historical foundation system of two Old Bridges from the Ottoman period in Bosnia and Herzegovina

S. Kulucija, M. Humo
Interprojekt d.o.o, Mostar, Bosnia and Herzegovina

ABSTRACT: Authenticity evaluation of cultural and historical buildings is one of the most important elements of their categorisation. Therefore, on the occasion of rehabilitation or reconstruction it is necessary to give special consideration to the correct assessment of state of existing foundation construction. Literature on historical foundations is very scarce comparing with literature on other structural elements, leading to a situation where engineers are seldom familiar with the problem. This paper provides description and more detailed research on foundations of two masonry arch bridges dating from the Ottoman period in Bosnia and Herzegovina, Old Bridge over the River Neretva in Konjic and Old Bridge over the River Drina in Visegrad. Upon examination on the spot, it has been established that both bridges have similar foundations i.e. multi-layered timber grillage.

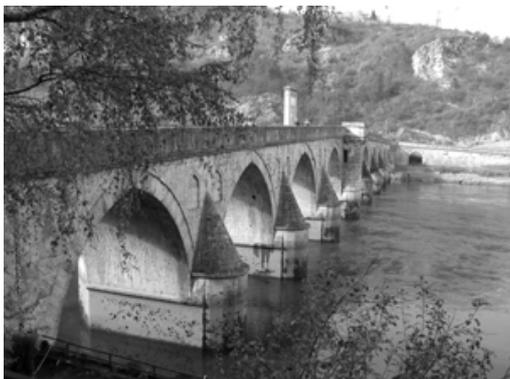
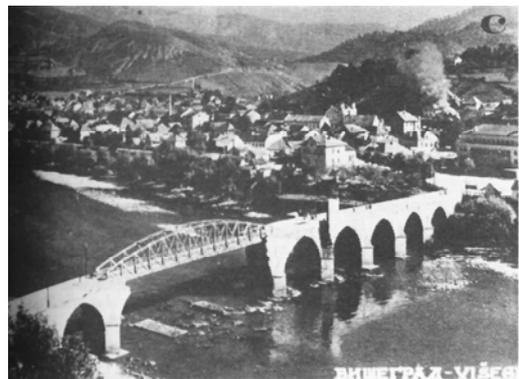
Figure 1: The Old Bridge in Visegrad to date (left) and 1935 (right); (NMA a)

During the intervening period, 1915 to 1939, the sections of the bridge that had been destroyed were provided with an iron structure to make the bridge passable, see Fig. 1 right. The bridge remained in this condition until 1939 when it was repaired. When the Germans retreated in October 1943 that part was also destroyed. After that, the bridge was reconstructed in the period from 1949 to 1952.

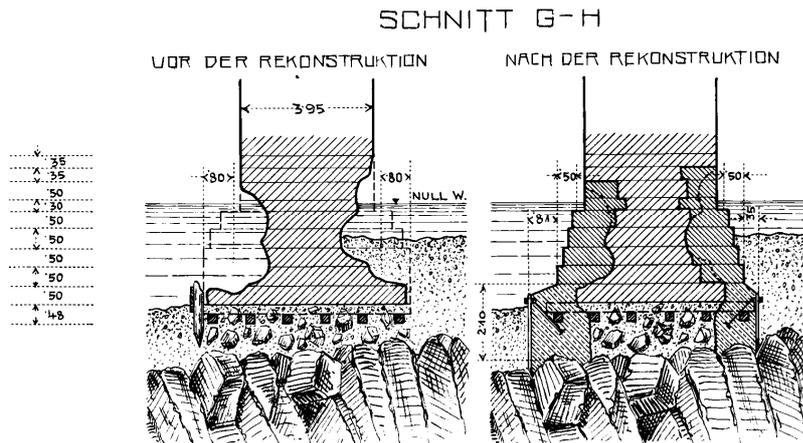
Figure 3: Pier 6, sec. G-H, plan of the existing condition and reconstruction proposal from 1911 (NMA c)

The archive plans of the existing condition in 1908 and 1909 show the foundations consisting of several, step-wise descending foundation layers and a double-layered timber grillage (NMA b). Some footings were lowered to the rocky substrata and in the places where the river is deeper, the foundation was made on the upper, coarse-grained, incoherent layer. Piles have not been noted, although they are mentioned in some references. One may consider them remains of the old cofferdams, and not short or long piles.

On basis of the above mentioned plans, Austro- Hungarian engineers made a reconstruction project in 1911. Repair works were carried out on the foundations of piers 4 to 9 in 1912. Pier marks are shown in the Disposition of the Bridge (Fig. 2).

The reconstruction plans were saved in the Commission to Preserve National Monuments of Bosnia and Herzegovina Archive, out of which one typical reconstruction plan for the pier foundation is outlined, see Fig. 3.

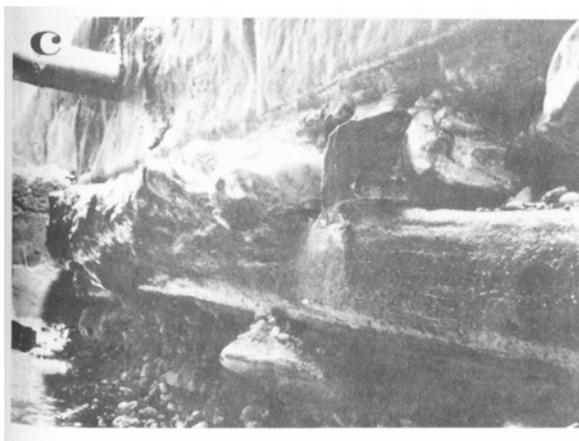
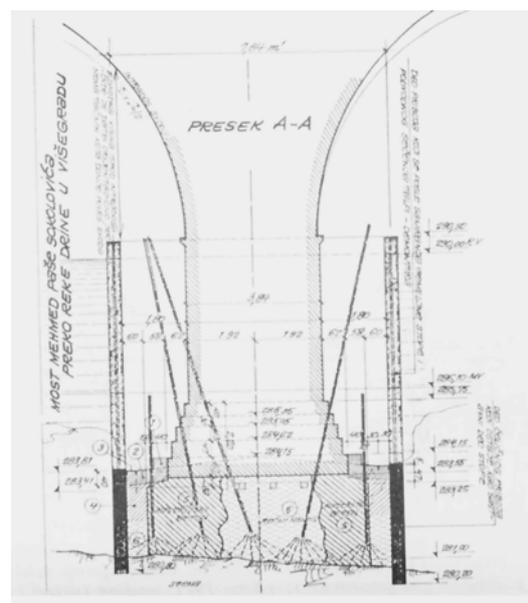
Figure 4: Details of the 1980/81 foundation repair (Gojkovic 1989)

After it was found in 1977 that the Bridge had suffered significant damages due to bad maintenance, heavy traffic and unfavourable influence by the accumulation reservoir of the Bajina Basta hydroelectric power plant, necessary research was conducted and a repair project developed. The Faculty of Civil Engineering in Belgrade developed the project. Some repair details, which professor Gojkovic published in his book 1989, are shown below.

- Carrying out all repair works on the foundations in dry conditions in order to achieve permanent improvement and desired quality;
- Providing the existing footings with a more suitable hydraulic shape in their lowest parts;
- "Lowering" the footings all the way to the rock by injecting river deposits, so to directly transfer great load to the rocky substrata.

During the years of 1980 and 1981, the foundations of three piers V, VI and VIII were repaired. At the end of 1981, the works were suspended due to lack of funds. In the meantime, the Visegrad hydroelectric power plant was built and put into operation. The projects for the Bajina Basta hydroelectric power plant downstream and the Visegrad hydroelectric power plant with a dam directly upstream from the Bridge endangered the foundations of this historical monument additionally.

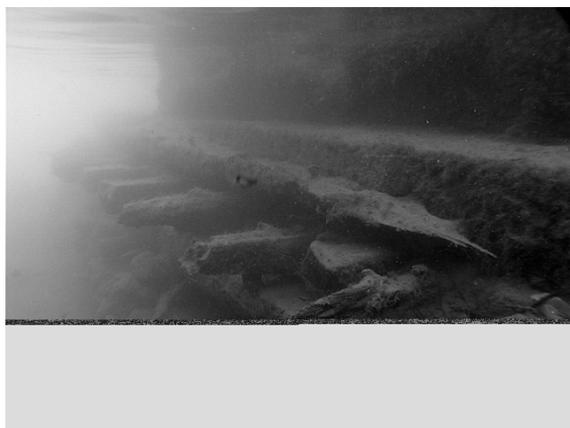
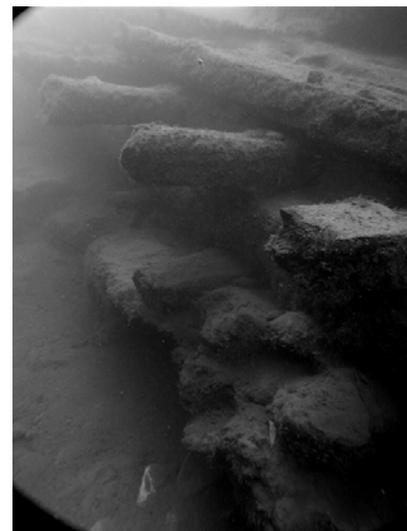
Figure 7: Underwater photo of the condition of the timber grillage, Pier 4; (FCE a)

The underwater recordings found wide timber grillages underneath the treated foundation layers, which are made of longitudinal and lateral timber beams joined together with forged nails and leaned against the rocky ground. The condition of the timber grillage at pier 4 is given in the image taken by the underwater camera (Fig.7). The foundation principle is practically identical in all four examined river piers, and only the arrangement, number, distance, dimensions and level of deterioration of the beams are different. Foundation layers and timber grillage are presented in a characteristic cross section of one of the examined pier foundations (Fig. 8). Both visible beams and those assessed to have existed were marked.

Regularly shaped stone blocks are placed between the outer ends of the beams, while the grillage is probably filled with broken stone in lime mortar. Technical conditions did not allow examining this more thoroughly. Broken stone material was drilled out of this level. The grillage beams were fastened using 35 to 40 cm long forged nails. Stone blocks of foundation layers were interconnected with iron cramps sealed with lead. The foundation layers are partly damaged and some beams of the timber grillage, which have been physically damaged over time and whose cross-section is reduced, are missing (or cannot be seen).

It has been shown that, from the load-bearing point of view, the foundation ground can take over the Bridge load with an adequate safety factor. In order to avoid washing out of the dolomite grus underneath the timber grillage over time, contact or bond injection grouting is suggested in case of some pier foundations, which would ensure and prolong the durability of this architectural structure. The foundation repair works haven't been performed at the time of writing this paper. The appropriate method will be decided within the design for the river bed treatment where the river flow and its destructive influence on foundations needs to be analysed and solution provided.

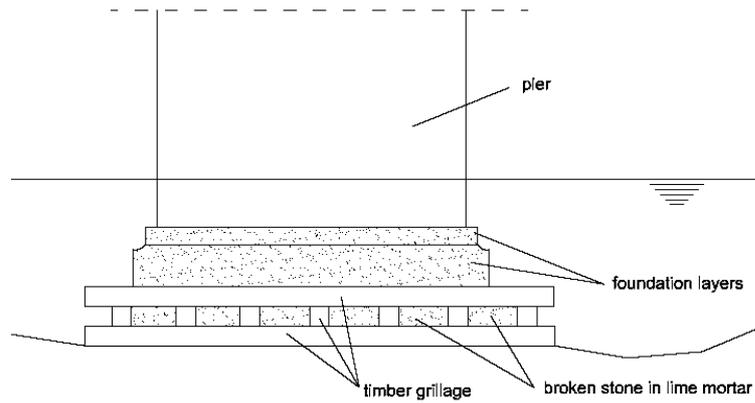
Figure 8: The characteristic cross section of the examined pier foundations

Preliminary analysis of the bearing capacity of the foundations was made based on these investigations. Permissible bearing capacity of 543 kN/m² with safety factor of three was obtained. Stresses obtained in some cross-sections, regardless of the timber grillage, are relatively low and they correspond to the cracked and dilapidated dolomite rocky ground (Table 1). According to the investigation, the current average strength of sample remnants of the timber grillage vertical to the fibre direction is 3.95 MN/m² and parallel to the fibre direction is 7.97 MN/m².

There is an especially complex problem with regard to finding an adequate calculation model for the foundation of piers on the timber grillage and for the assessment of its future role and of the level of deterioration and safety. It is possible that the timber grillage has a predominantly structural role, as an element of aseismic construction. This problem has not been discussed here any further. It has been presented above that the analysed cross-section, without the co-influence by the timber grillage, has adequate bearing capacity.
