Seismic strengthening and repair of typical stone masonry historical buildings in Bosnia and Herzegovina

HRASNICA, MUSTAFA¹; ZLATAR, MUHAMED²; KULUKCIJA, SALKO³,
HUMO, MUSTAFA⁴, MADZAREVIC, MUHAMED⁵

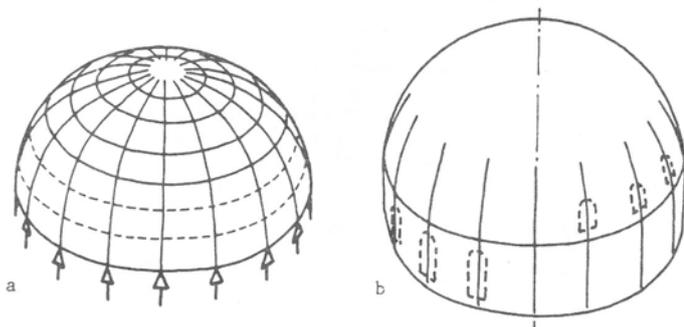
Figure 2. Structural system and cracks in the dome masonry structure

The large majority of all historical buildings are built as masonry structures, a lot of stone masonry, but in some regions bricks masonry as well. They are traditionally built as unreinforced masonry without confining elements. In some regions timber confinement was used. Typical curved structural forms as domes, arches and vaults are often part of historical buildings especially the religious ones. As they are built as unreinforced masonry structures, the historical buildings are relatively stiff and show generally brittle behavior. So, the first damages in form of cracks appear already by moderate earthquakes on softer structural elements as domes and arches [4], or ceilings attached to wooden floors and on partition walls, if there are any. At the same time the main structure, as thick walls and abutments, is in linear range of the behavior, with no or almost no cracks. But, it's generally not the case for very strong earthquake motion.

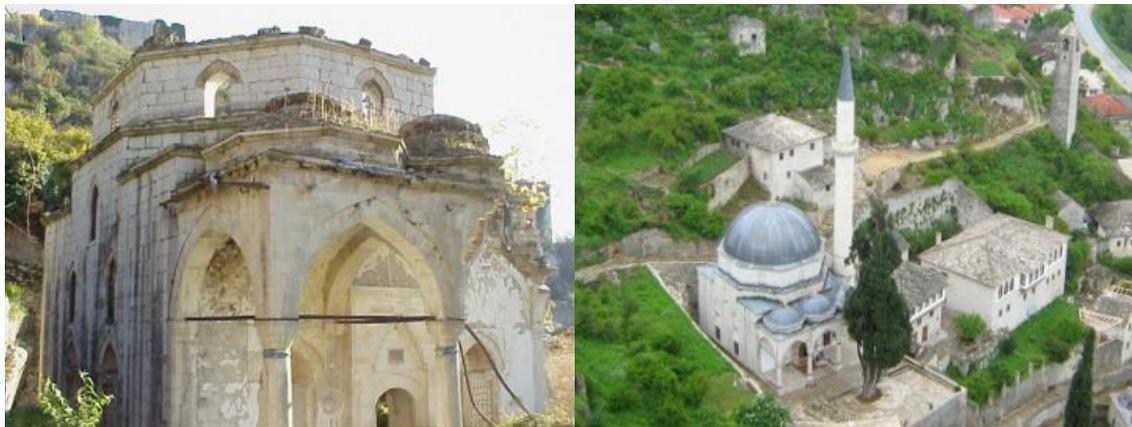
Figure 3. Destroyed and reconstructed mosque building in Počitelj

Minaret (mosque tower), central great dome, one small dome close to the minaret and two porch columns were completely destroyed. The middle small dome was partly destroyed and the third dome damaged. Cracking and local damages were significant at the rest of the building structure visibly increasing towards the top and the minaret side. An additional stone foundation layer laid on a rocky substructure was identified by excavating two pits. Material characteristics, used for analysis, such as volume weight and compressive strength were taken from the literature or from previous testing results. Detailed testing was performed only for tufa stone due to known significant differences among samples from different quarries.

The mosque was built in 1562-63, the early period of Ottoman ruling in Bosnia and Herzegovina. During the recent war in 1993 the minaret and the dome were completely destroyed and the rest of the building badly damaged by explosion. Guidelines for rehabilitation and protection of historical urban site of Počitelj were set in 2001 by the expert group and led to reconstruction design [5] for the mosque in 2002 and further to reconstruction works in 2003 (Figure 3).

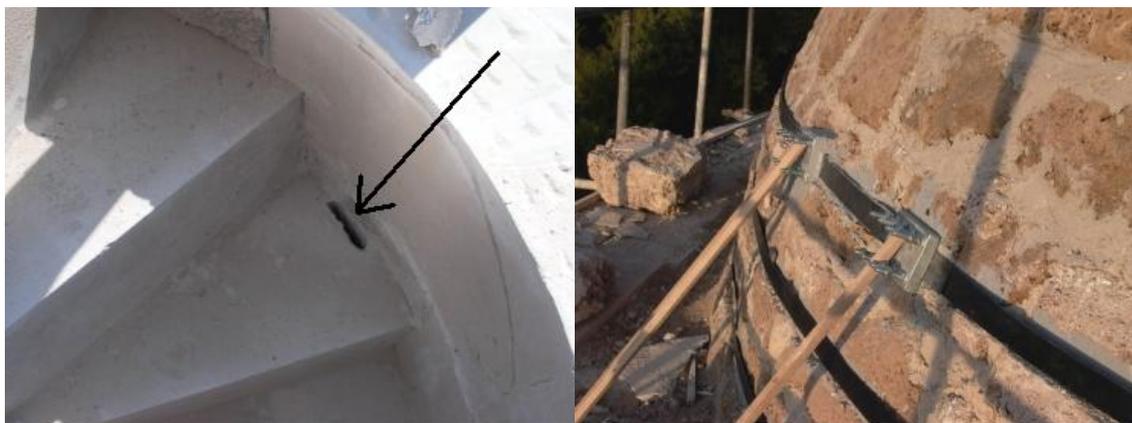
Figure 4. Strengthening solutions for minaret and dome, mosque in Počitelj

The minaret is 1300kN. The section area at the bottom is $4N/mm^2$ due to self weight. This is approximately one compressive stress of $2.50N/mm^2$ according to DIN 1053 time for this analysis. The influence of the horizontal load, to increase in compressive stress up to $1.33N/mm^2$. One at the end of transition from 600mm to 260mm. Most of the joints are opened and at the critical zone the cross-section, which led to decision on reinforcing one was identified to be between levels +8.55m and

in accordance with partial safety factor concept, where carbon fiber strips (CFRP) spread uniformly along the compressive strength of masonry is $4N/mm^2$ with safety factor of 1,1. The strength of CFRP strips is $1236N/mm^2$ with safety factor of 1,1. and for masonry in accordance with EC6. Partial safety factor 1.5 for wind load. Sika CarboDur S812 strips of 12m and later on chosen for the construction. Technical staircase was solved by leaving voids in stair masonry reinforcing the bottom part on the outer side of the main and fixing with a bolted steel plates (Figure 4).

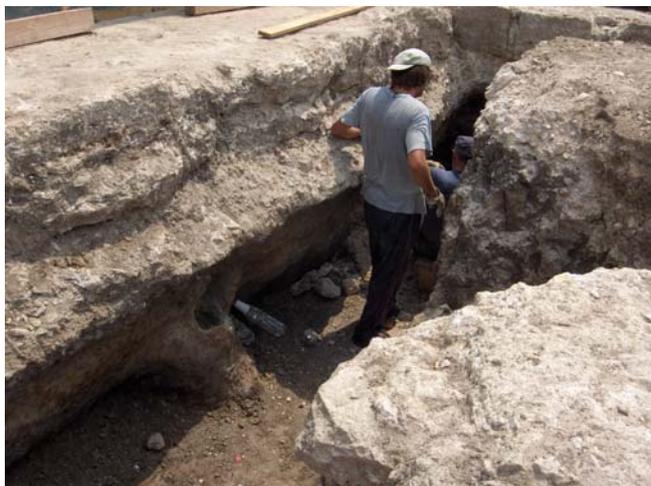
The foundation structure comprises the stone strips with two layers of rather fine shaped stones. Under the stone stripes slender timber piles were built in. The mosque was completely destroyed, only original foundation structure was left behind (Figure 6). The rehabilitation project comprises rebuilding with completely identical geometrical dimensions and as far as possible the use of the same materials. Due to the fact that the mosque building was completely destroyed, rebuild means in reality erection of the new building, which should include the implementation of modern structural codes. This leads to conflicts between demands of new codes and old historical stone structures, which don't fulfill them. It is especially expressed in the case of seismic codes. The city of Banja Luka is situated in a high seismic intensity zone (zone IX according to MKS-scale), which simply means relatively high horizontal forces acting on the mosque structure. The structural analysis was done already in 2002 using SAP2000 program. The mosque building structure is relatively stiff, but the free part of the minaret has first vibration period of roughly one second. The stone weight was calculated with 20 KN/m³, elasticity module with 3000-5000 MN/m².

Figure 6. Only foundation left after severe destruction, investigation of foundation structure

The first problem of rehabilitation works was very shallow existing foundation structure. It was tightened and strengthened by reinforced concrete jacketing on micro-piles with the diameter of 20cm. Another strengthening is previewed in a lower part of the dome in the direction of ring forces. A sort of reinforced concrete ring should be built in. According to the performed structural analysis minaret cannot withstand the earthquake of intensity grade IX. Two solutions were discussed. The first one with vertical reinforcement built in masonry stones. Second solution was built in of CFK-strips on the outer face of minaret cross-section. Disadvantage of this solution is of esthetical nature, while the carbon strips disturb the original appearance of minaret. The rehabilitation work has not been finished yet and the mosque is still under construction.

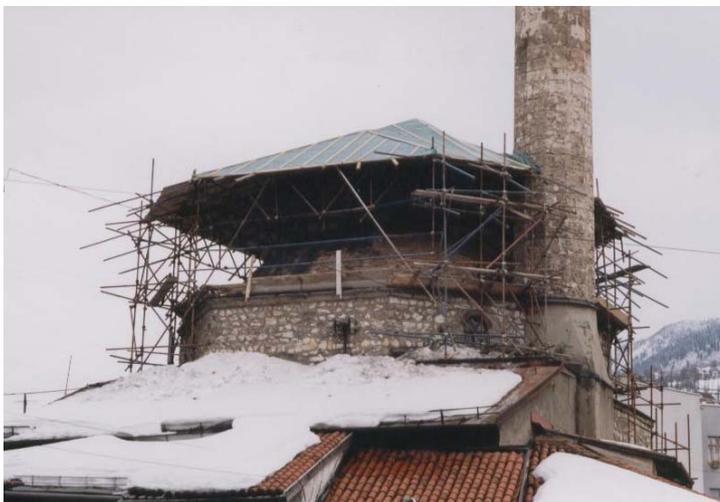
The mosque was built in 1526 in the old city of Sarajevo, one of the first mosques with the dome constructed during Ottoman period in Bosnia and Herzegovina (Figure 7). The mosque is situated in the heart of the old city and was very popular among the inhabitants. The small oriental stores are directly leaned to the mosques walls. This mosque was not destroyed during the last war 1992-95. There were some smaller damages due to bomb splitting during shelling of the city of Sarajevo from the surrounding hills. The most recognized damages can refer to the durability problems of masonry structure, especially due to the relatively bad hydraulic mortar. First rehabilitation works were done in 1969 and the last in 2000 [7].

Figure 7. Čekrekčija mosque in Sarajevo under reconstruction

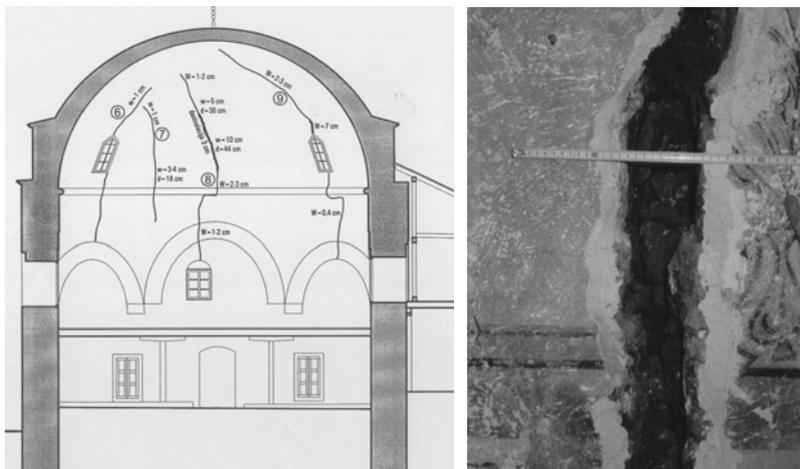
Figure 8. Schema of the observed cracks and crack detail

The observed damages were cumulated through the centuries. Probably first hair cracks had opened during some earthquake motion in the history and during the time they became larger. The most of the damages were concentrated in the mosque dome, and partially in the walls. The cracks were typical for this type of the masonry structures, going in meridian direction (Figure 8). The cracks width was mostly in the range from 1 to 10 cm. They can be estimated as very large cracks. Even, few displacements perpendicular to the dome surface between two portions of the dome divided by the crack were observed. They were in the range from 3 to 12cm. Obviously, the mosque dome was substantially damaged. At the same time there were no damages registered on minaret. One can conclude that instead of original space type of the dome structure few plane arch structures were formed, which provided the roof stability, but not the functionality.

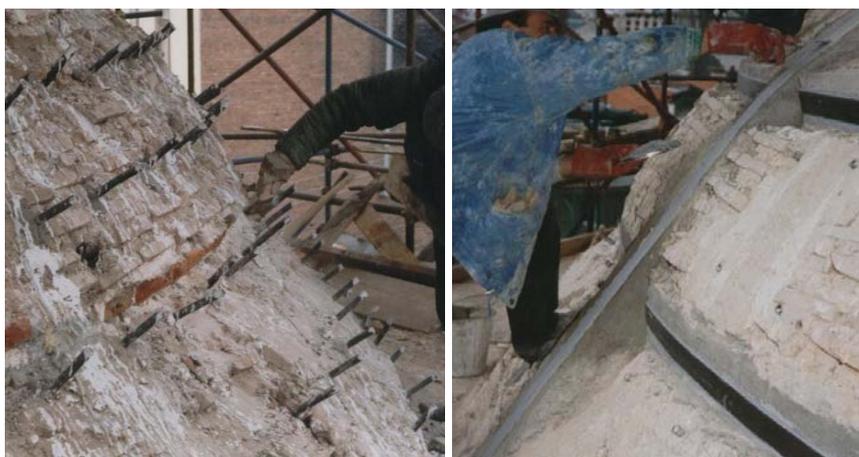
Figure 9. Injection of cracks and built in of carbon strips

However, it was recommended to rehabilitate the structure, which was done. All cracks were injected with special mortar mixture (Figure 9). After the first structural analysis the strengthening with carbon strips was recommended. But during reconstruction works, because of evidently large cracks and shear displacement, the dome was degraded and then rebuilt again. So the strengthening with carbon strips (Figure) has not been even necessary.
