Existing historical foundation system of two Old Bridges from the Ottoman period in Bosnia and Herzegovina

S. Kulucija, M. Humo
Interprojekt d.o.o, Mostar, Bosnia and Herzegovina

ABSTRACT: Authenticity evaluation of cultural and historical buildings is one of the most important elements of their categorisation. Therefore, on the occasion of rehabilitation or reconstruction it is necessary to give special consideration to the correct assessment of state of existing foundation construction. Literature on historical foundations is very scarce comparing with literature on other structural elements, leading to a situation where engineers are seldom familiar with the problem. This paper provides description and more detailed research on foundations of two masonry arch bridges dating from the Ottoman period in Bosnia and Herzegovina, Old Bridge over the River Neretva in Konjic and Old Bridge over the River Drina in Visegrad. Upon examination on the spot, it has been established that both bridges have similar foundations i.e. multi-layered timber grillage.

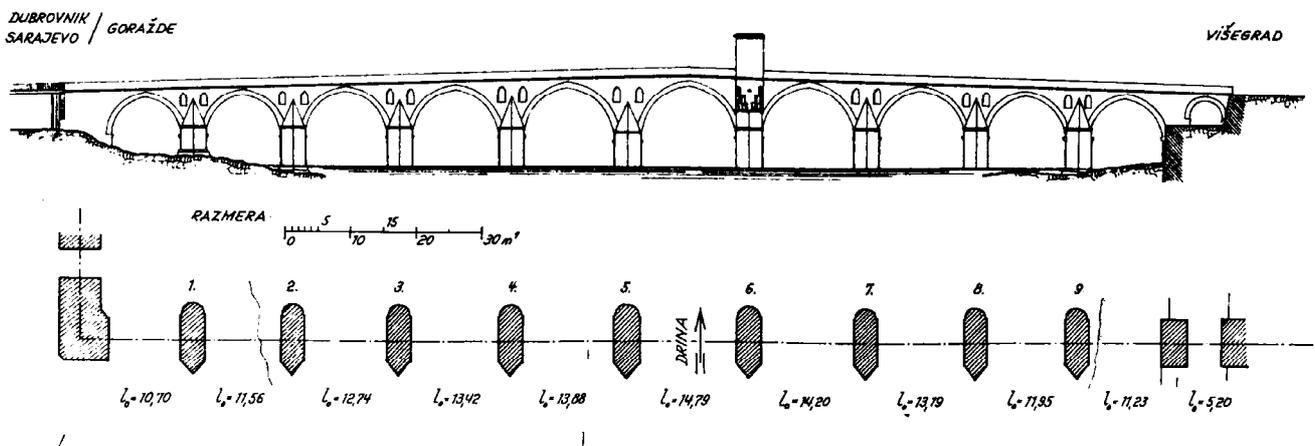
Figure 2: Disposition of the Bridge (Gojkovic 1989)

On basis of the above mentioned plans, Austro- Hungarian engineers made a reconstruction project in 1911. Repair works were carried out on the foundations of piers 4 to 9 in 1912. Pier marks are shown in the Disposition of the Bridge (Fig. 2).

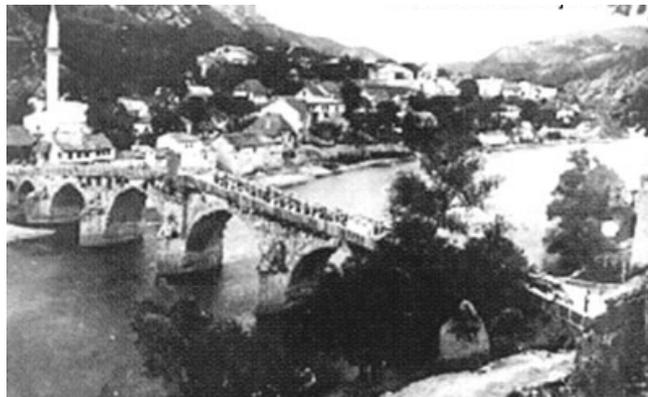
Figure 5: The Old Bridge in Konjic before 1945 (GDH a)

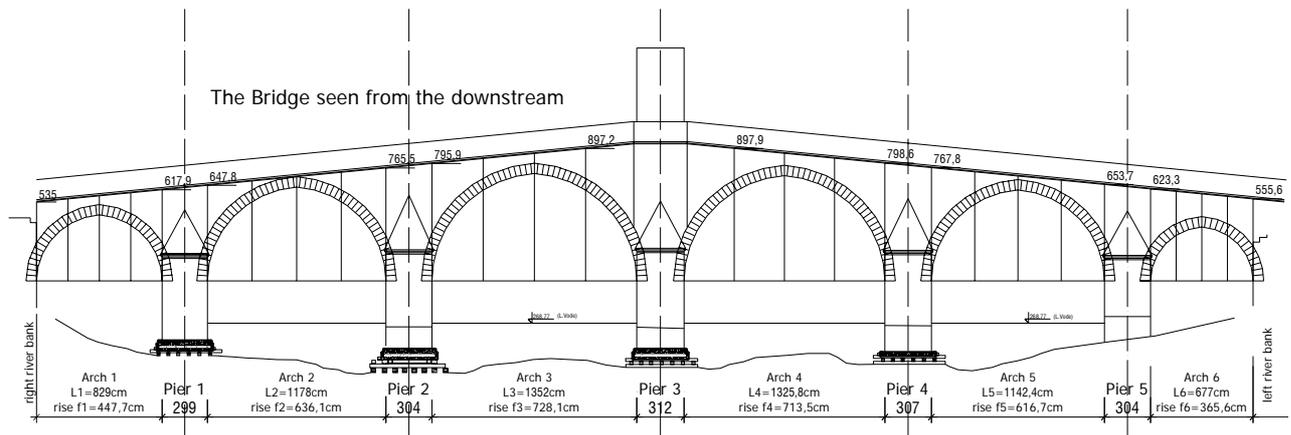
The stone bridge is set on six pointed stone arches with a span ranging from 6.77 to 13.52 m. The distance between the arch intrados and water level during the summer period, ranges from 4.30 to 8.70 m. The arches rest on five stone masonry piers and two abutments on each river bank. The piers, which belong to the original state, are 3 m wide (with minor variations), and 5.25 m from side to side of the bridge in the direction of the current stream. On the upstream side the piers terminate in prominent triangular breakwaters, and on the downstream side in polygonal buttresses ending in pyramidal shape and terminating on the spandrel walls on both upstream and downstream sides. The arches of the bridge begin at approximately half the height of the vertical part of the piers, on a gently slanting cornice, and follow the line of a pointed arch increasing symmetrically from aperture to aperture from each bank towards the centre of the bridge. The end arches, smaller in span and rise, rest on piers and abutments (Fig. 6).

Figure 6: The Old Bridge in Konjic, downstream elevation
