Seismic strengthening and repair of typical stone masonry historical buildings in Bosnia and Herzegovina

HRASNICA, MUSTAFA¹; ZLATAR, MUHAMED²; KULUKCIJA, SALKO³,
HUMO, MUSTAFA⁴, MADZAREVIC, MUHAMED⁵

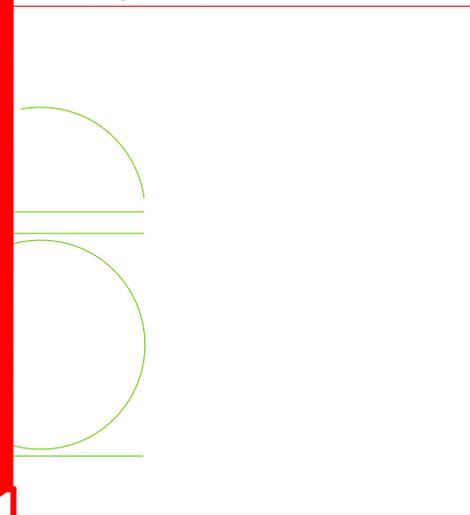
The mosque was built as stone masonry building. The non-regular shape of the mosque (Figure 5) in a plan comprises the central part of 9x9m size covered by a hemispherical dome, two side-rooms of 3x9m and front part of 4.5x9m, all three covered by one half of hemispherical dome. Entrance area of approx. 15x5m is covered by three smaller hemispherical domes. The top of the domes is 18 m above the ground level. The total height of the minaret (mosque tower) is 43 m.

Rehabilitation project [6] started in 2001. During design phase a lot of discussions were conducted regarding construction method and appropriate structural analysis. A special topic was seismic design due to the fact that the mosque is situated in the highest seismic zone in Bosnia and Herzegovina.
